# A Sacrificial Anode Retrofit Program for Existing Cast Iron Distribution Water Mains

JEFF SCHRAMUK, *NACE Cathodic Protection Specialist*  
DANNY J. KLOPFER, *Des Moines Water Works*

**For more than a decade, Canadian water utilities have been using an innovative installation technique for retrofitting cathodic protection anodes to existing water mains. In 2003, a similar sacrificial anode retrofit program was undertaken in a U.S. city to reduce its main breaks and extend the life of its system. The results of a 2003-2004 pilot program show that a 20-year life extension can be achieved at less than 10% of the replacement cost of the piping.**

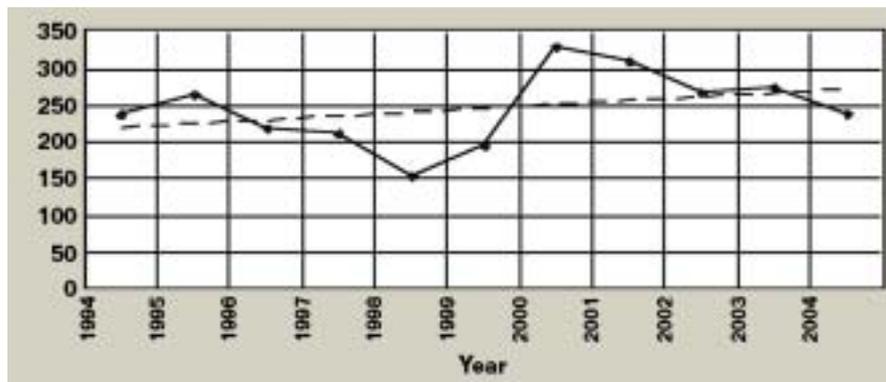
FIGURE 1

The Des Moines (Iowa) Water Works (DMWW) currently is responsible for maintaining 1,013 miles (1,630 km) of water distribution piping. Current water main break rates are now at ~27 breaks per 100 miles (161 km) of pipe. The trend in main breaks from 1988 to the present time has shown a steady increase in failure rates (Figure 1). Most of the water main breaks in the distribution system are either directly or indirectly related to corrosion, excluding third-party excavation damage to the pipe.

Total main breaks per year.

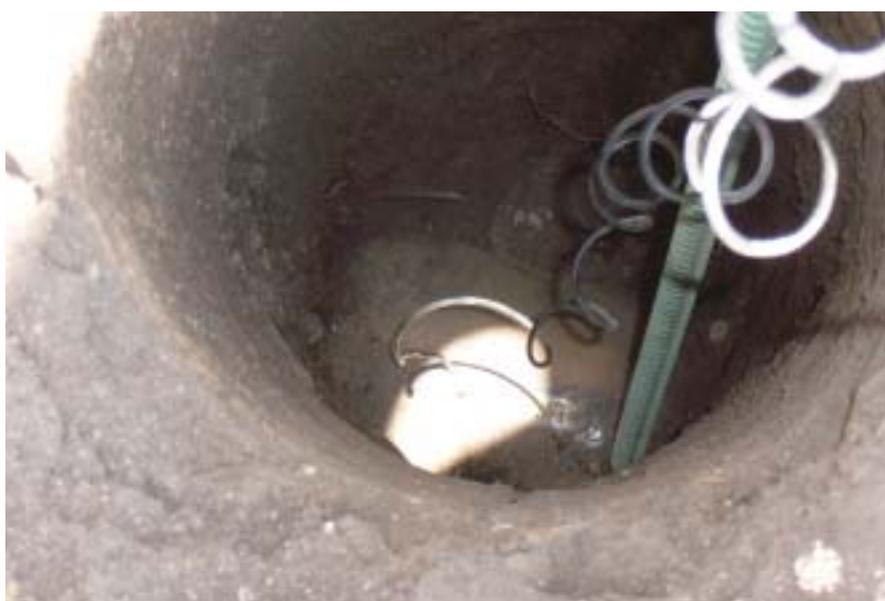
FIGURE 2

The anode borehole is initiated by a backhoe-auger that drills through the pavement or surface soils down to ~12 in. (0.3 m) above the pipe. To avoid damage to the buried waterline, the method then utilizes vacuum extraction equipment to remove the remaining soil in the hole down to the top of the buried pipe. Once the top of the pipe is exposed and cleaned, a carbon steel stud is arc-welded to the top of the pipe (Figure 2). The arc welder is run from a portable field generator.

Steel stud arc welded to the top of the pipe.

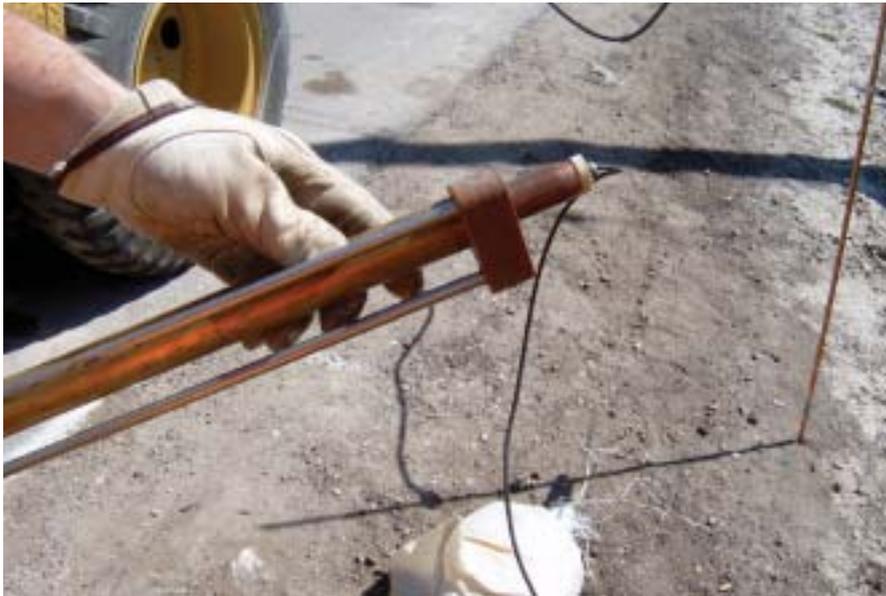
**FIGURE 3**

A special insulated extension tool was fabricated to allow the welder to reach to the top of the pipe and contact the pipe surface. The stud is silver-soldered to each anode's #12 AWG lead wire, and the stud fits snugly into a tapered copper sleeve in the end of the extension tool (Figure 3). The extension tool is connected to the welder's trigger handle by high-capacity insulated cables. A steel rebar is used to make the ground connection between the pipe and the welder, also using an insulated cable. When electrical continuity is verified between the stud and the rebar ground, the operator initiates the welder by pushing a button in the trigger handle.

Stud fits in the end of the extension tool.

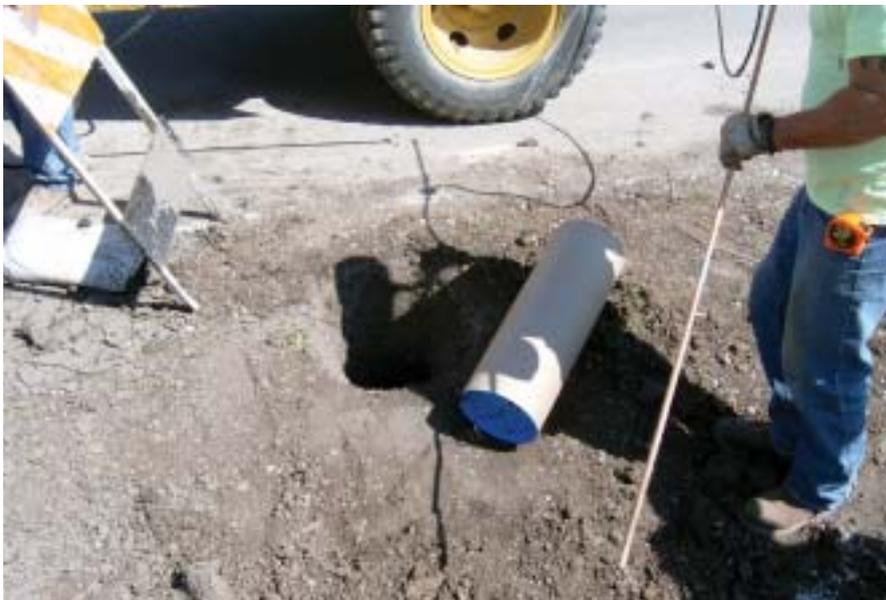
**FIGURE 4**

After the stud weld is verified to be secure, the prepackaged sacrificial anode is lowered down into the hole (Figure 4). To achieve the greatest life, a 32-lb (14.55-kg) high-potential magnesium anode was specified for all installations. A 6- to 12-in. (152- to 305-mm) layer of sand/limestone fines is poured into the hole over the weld to ensure that the an-

Prepackaged sacrificial anode is lowered down into the hole.

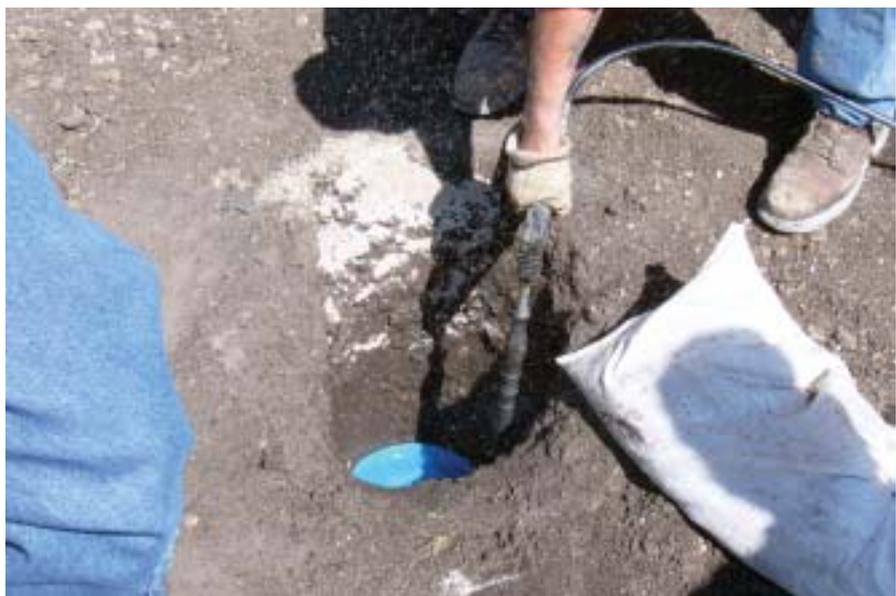
**FIGURE 5**

ode does not rest directly upon the stud. Although the paperboard anode canister is filled with a low-resistance, hygroscopic material, ~5 gal (19 L) of water is poured into the hole to ensure maximum anode current flow to the pipe (Figure 5). Compacted native soil fills the balance of the hole. Pavement restoration or turf replacements complete the installation.

Anode is backfilled with limestone fines, native soil, and water.
