A sacrificial anode retrofit program for existing cast-iron distribution water mains

PUBLIC WATER UTILITIES FACE A SIGNIFICANT ECONOMIC BURDEN CREATED BY THE DETERIORATION OF THEIR WATER DISTRIBUTION SYSTEMS. APPLYING CATHODIC PROTECTION (CP) CAN EXTEND THE LIFE OF AN EXISTING WATER DISTRIBUTION MAIN SYSTEM.

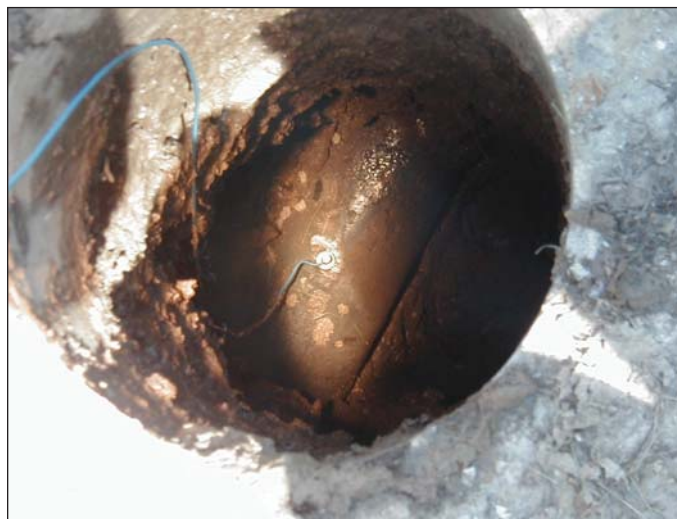
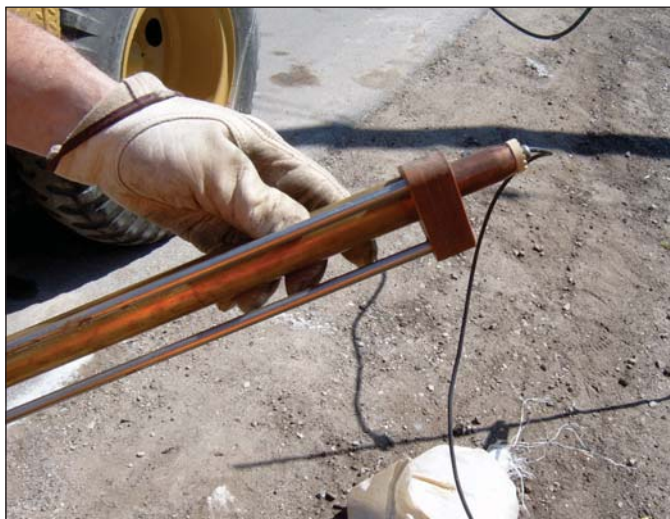
After an anode borehole is drilled and the remaining soil is removed with vacuum extraction equipment, a steel stud is welded to the top of the pipe (left). The stud fits into the end of an insulated extension tool (right) that is used to allow the welder to reach the top of the pipe and contact the pipe surface.

CP anode installation technique. The anode borehole is initiated by a backhoe-auger that drills through surface materials down to about 12 in. (30 cm) above the pipe. To avoid damage to the buried water line, vacuum extraction equipment is used to remove the remaining soil in the hole down to the

top of the buried pipe. Once the top of the pipe is exposed and cleaned, a stud is arc-welded to the top of the pipe (photo top left).

An insulated extension tool is used to allow the welder to reach the top of the pipe and contact the pipe surface. The stud is soldered to each anode's number 12 American wire gauge (AWG) lead wire, and it fits snugly into a tapered copper sleeve in the end of the extension tool (photo top right). The extension tool is connected to the

welder's trigger handle by high capacity insulated cables. A steel rebar is used to make the ground connection between the pipe and the welder, also using an insulated cable. When electrical continuity is verified between the stud and the rebar ground, the opera-

tor initiates the weld by pushing a button on the trigger handle.

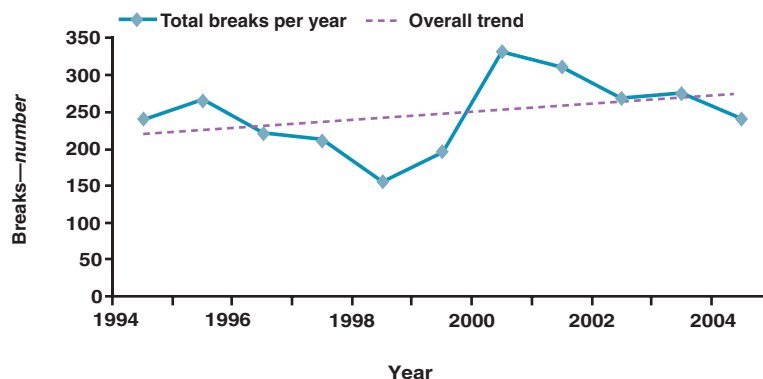
FIGURE 1 Total main breaks per year for Des Moines Water Works

The DMWW is currently responsible for maintaining 1,013 mi (1,630 km) of water distribution piping. Water main occur at a rate of approximately 27 breaks per 100 mi (161 km) of pipe. The trend in main breaks from 1994 to present day includes a steady increase in failure rates (Figure 1). Excluding third-party excavation pipe damage, most of the water main breaks in the system are related to corrosion.

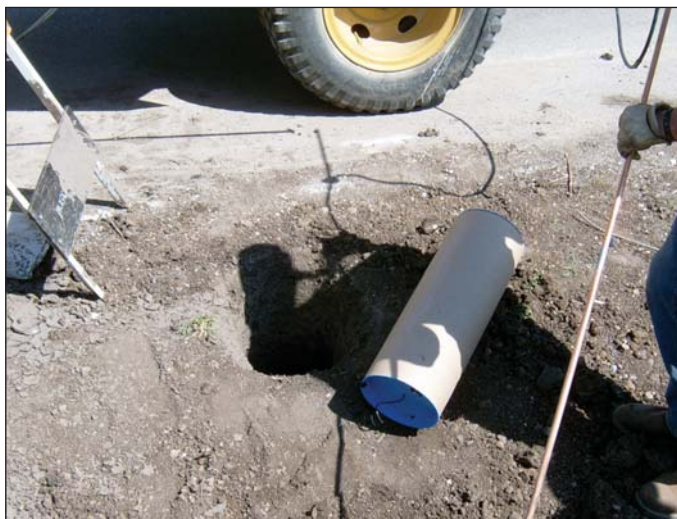
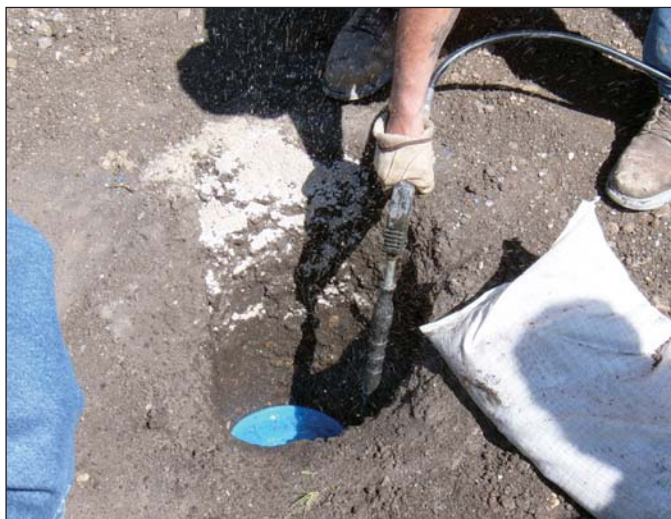
Once the stud is attached and the weld verified as secure, the prepackaged sacrificial anode is lowered into the hole (left). After it is placed in the hole, the anode is backfilled with limestone fines, native soil, and water (right).

(photo top right). Compacted native soil fills the balance of the hole. Pavement restoration or turf replacement completes the installation.

After the stud weld is verified as secure, a 6–12-in. (15–30-cm) layer of sand/limestone fines is poured into the hole over the weld to ensure that the anode does not rest directly on the stud. A prepackaged sacrificial anode is then lowered down into the hole (photo top left). To achieve the greatest life, a 32-lb (14.55-kg) high-potential magnesium anode was specified for all installations. Although the paperboard anode canister is filled with a low-resistance (hygroscopic) material, the hole is also backfilled with about 5 gal (19 L) of water to ensure that the anode can maximize current flow to the pipe

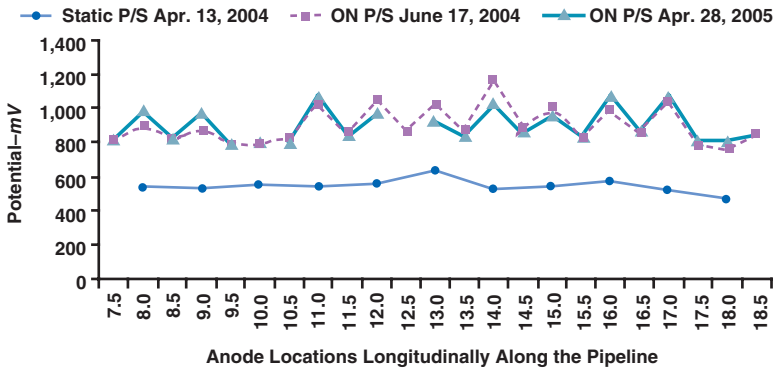
FIGURE 2 Potential profiles for Muskogee Avenue (stations 7.5–18.5)

ON P/S—pipe-to-soil potential after cathodic protection, static P/S—pipe-to-soil potential before cathodic protection

Whole number values indicate locations at which anodes are installed; half number values indicate midpoints between anodes. Anodes are about 60 ft apart.

All P/S referenced to copper/copper sulfate electrode

Typical potential profiles for Muskogee Avenue and 8th Street (Figures 2 and 3) indicate a shift of more than 100 mV, with the exception of one location on Muskogee Avenue in an area in which the pipe is believed to be electrically discontinuous. No potential measurements were made on 3rd Street before the anode installations; however, the current-applied potentials of 1,000 mV indicate the sacrificial anodes are significantly raising the water main’s potential along this section of main.
