CPSI Project Showcase - Stray DC Interference

Problem: Corrosion Failure of New Water Transmission Main

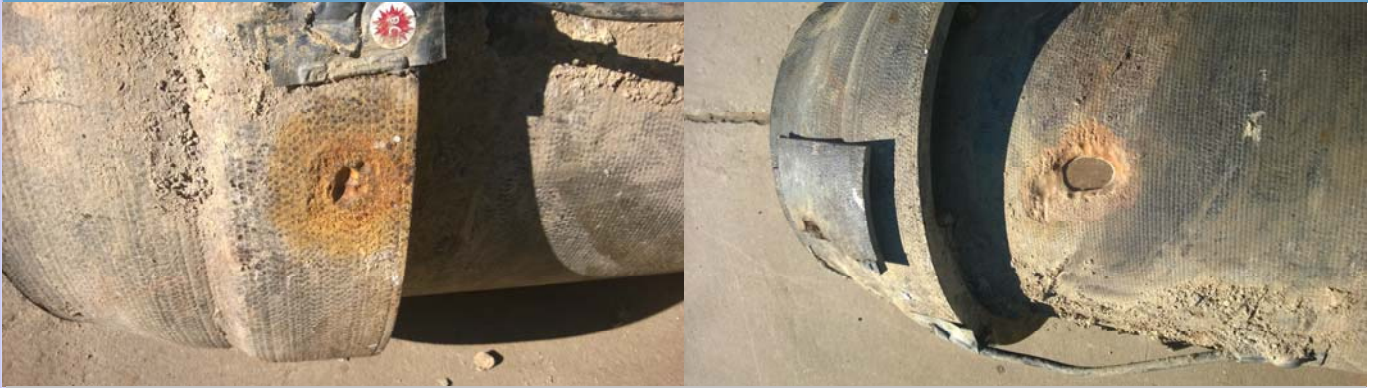
- ◆ New ductile iron water pipe installed failed in less than 18 months
- ◆ DC interference from foreign rectified-anode CP system causes corrosion failure
- ◆ Water utility must replace pipe section and correct problem before service can be restored

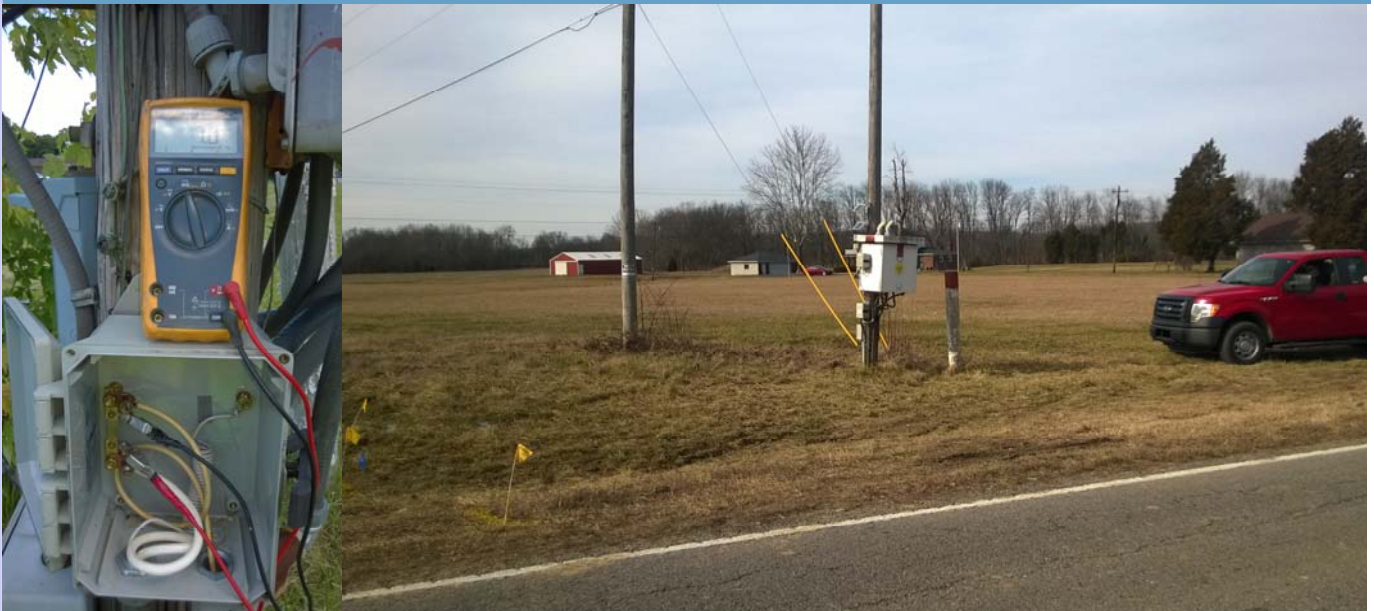
Solution: Install Interference Bond to Drain DC Current

- ◆ New water pipeline is restored to service with minimal disruption
- ◆ DC interference from foreign rectified-anode CP system is able to be properly managed
- ◆ Water utility has the means and measures to verify the interference problem is mitigated
