# CPSI Project Showcase - Sewage Pump Station

Problem: Corrosion of External Shell of Buried Pump Station Chamber

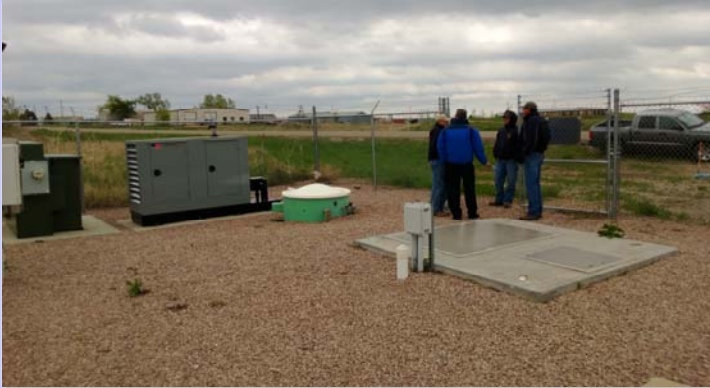
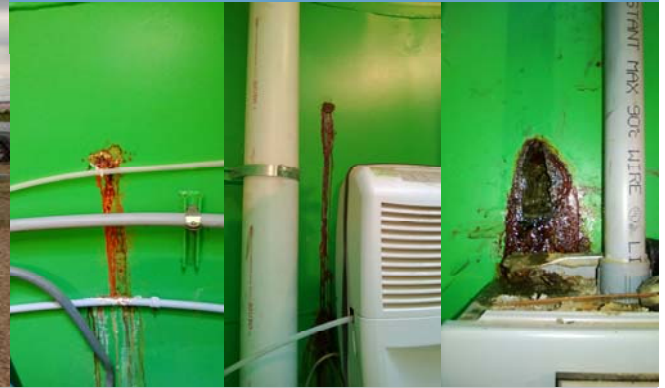
- ◆ Buried carbon-steel pump chamber is vulnerable to external corrosion failure
- ◆ Ground water entering pump chamber deteriorates reliable pumping operations
- ◆ Sewage utility could not afford a corrosion failure on such critical infrastructure

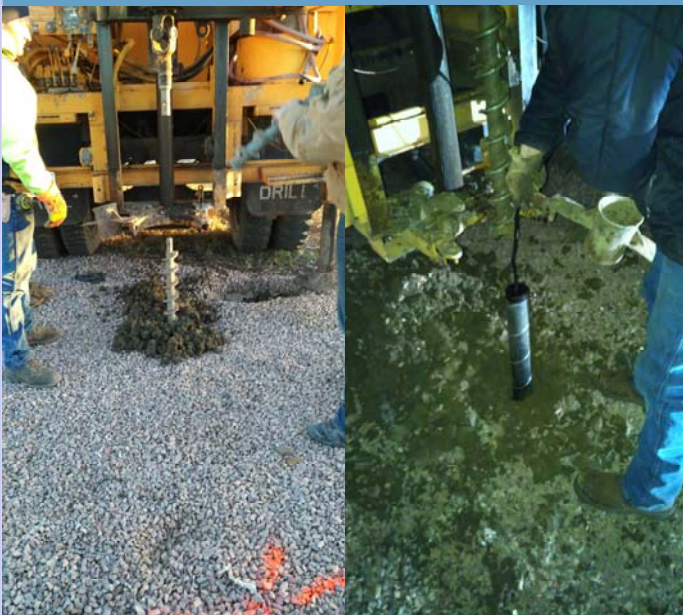
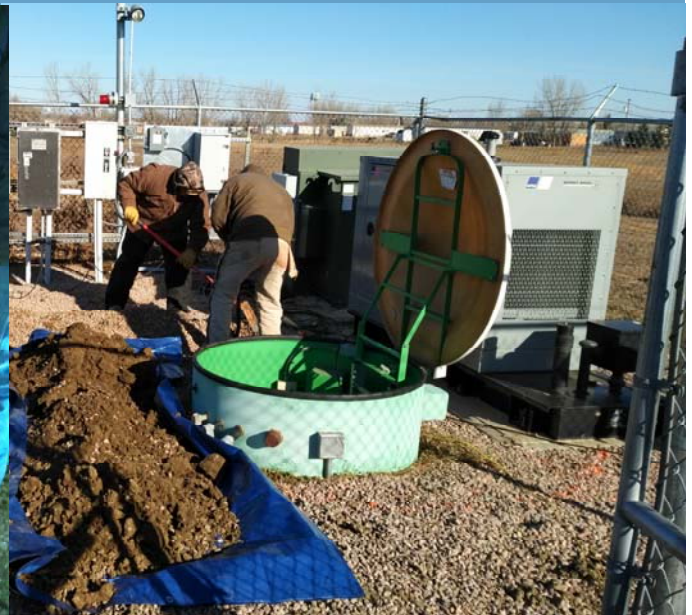
Solution: Install Rectified Anodes to the Buried Pump Station Chamber

- ◆ Rectified-anode CP systems were installed surrounding the buried pump station
- ◆ Further corrosion is being mitigated through the application of cathodic protection
- ◆ Sewage utility can maintain its critical infrastructure knowing that corrosion is mitigated
