CPSI Project Showcase - Particle Physics Piping

Problem: Corrosion of Evacuated Sub-Atomic Particle Beam Piping

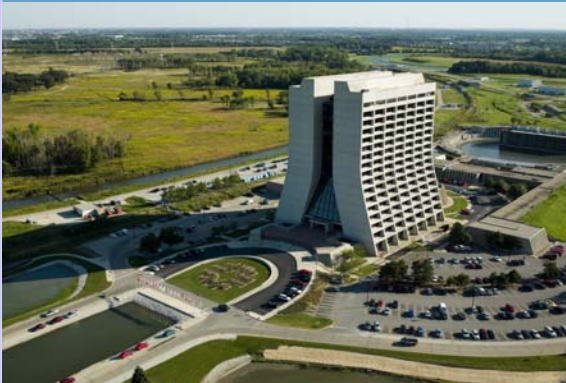
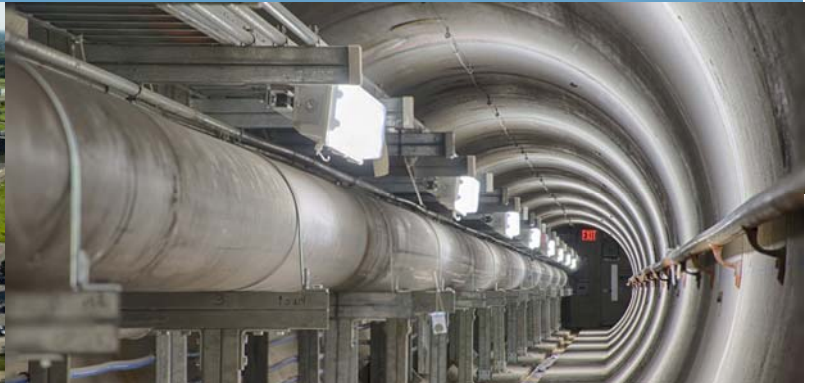
Issues Relating to the Customer's Corrosion Problem:

- ◆ Buried high-energy/particle-beam/carbon-steel piping is vulnerable to corrosion failure
- ◆ If beam piping corrodes, vacuum is lost—shutting down high-energy physics research
- ◆ Research laboratory could not afford a corrosion failure on such critical infrastructure

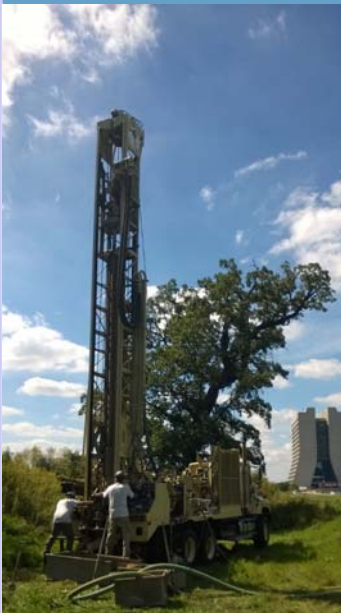
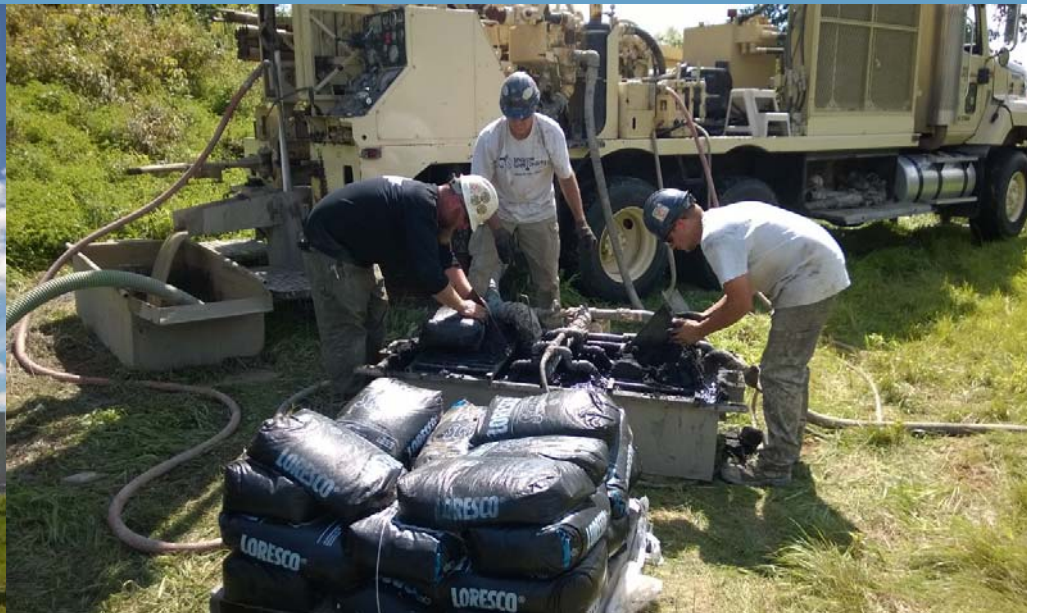
Solution: Retrofit Rectified Anodes to the Buried Particle Beam Piping

- ◆ Rectified-anode CP systems were installed at select locations along the beam piping
- ◆ Further corrosion is being mitigated through the application of cathodic protection
- ◆ Research facility can maintain its critical infrastructure knowing that corrosion is mitigated
